Manhole Inspection Summary

Manhole # S17CC1019MH

Insp Date: **2/28/07 8:34 AM**

Location Address: **2267 PARK HILL AVE**

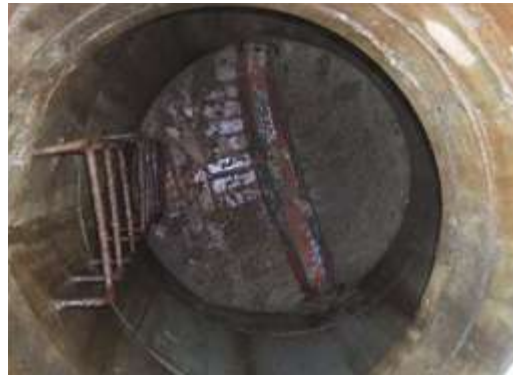
Top View

Corroded steps. Evidence of surcharge - Bench debris. Channel debris.

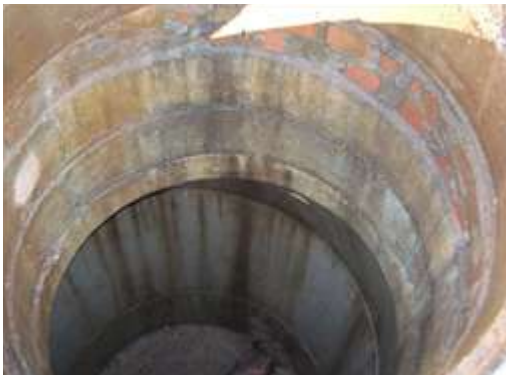
Defect

Frame leaks. Adjustment infiltration.

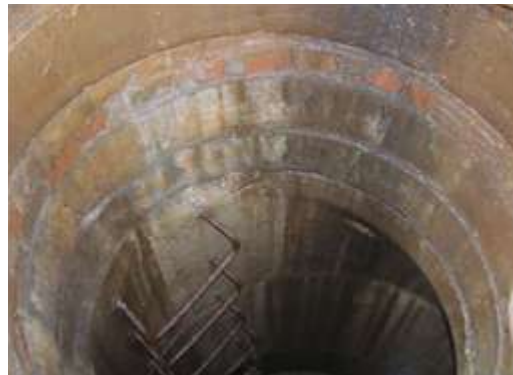
Defect

Frame leaks. Adjustment infiltration

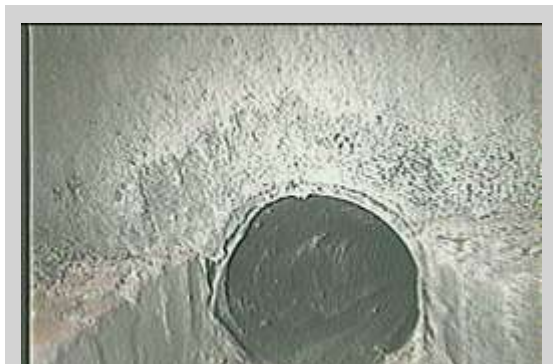
Pipe Out @ 12 O'Clock

Infiltration: **Evidence** Pipe Seal Cond: **Unknown**

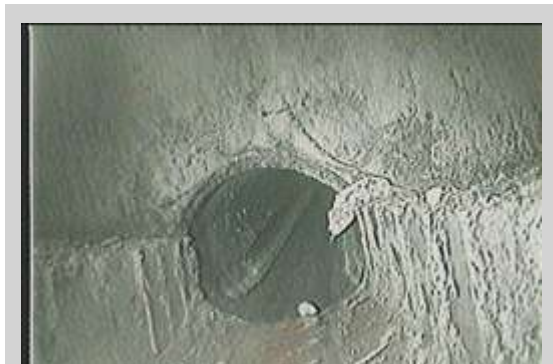
Pipe In @ 5 O'Clock

Infiltration: **Evidence** Pipe Seal Cond: **Unknown**
